Study of the ozone depletion and global warming potentials associated with fridge recycling operations that involve the manual stripping of polyurethane insulation foam

**14 September 2010
Darmstadt, Germany**

RAL–Gütegemeinschaft Rückproduktion von
Kühlgeräten e.V.

Öko-Institut e.V.

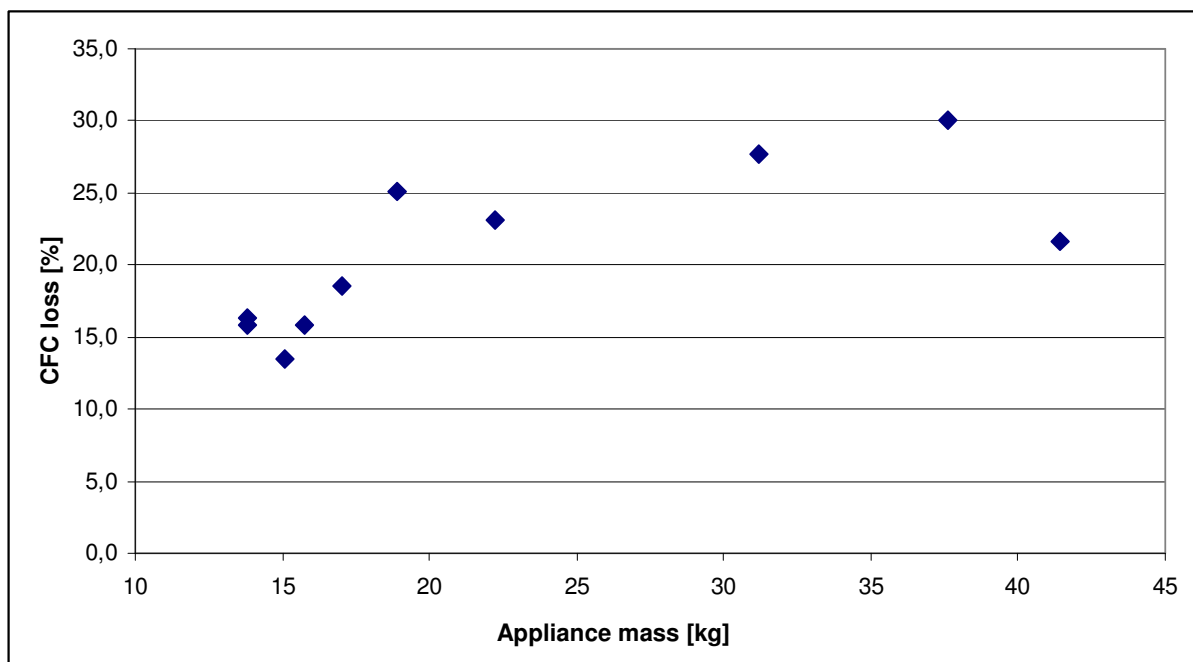
The following diagram shows the CFC losses determined for the entire appliance carcass (cabinet plus door) plotted as a function of appliance weight prior to manual foam stripping.

Figure 2.1 Correlation between appliance mass and CFC losses

The diagram indicates that heavier appliances exhibit significantly higher CFC loss levels. Whereas the CFC losses of 15% are found for appliances weighing around 15 kg, the three appliances with weights of over 30 kg show significantly higher losses (up to 30%).

Because of the small number of appliances in each weight class it is not possible to establish whether or not this is a general trend. A correlation between CFC loss and the average quantity of PU foam recovered from the manual dismantling process would

seem more probable. However, in the tests performed the amounts of PU foam recovered from each appliance were all in the same approximate weight range.

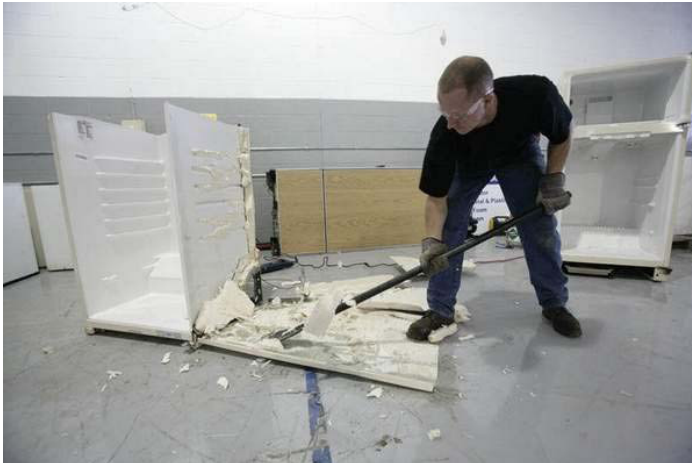
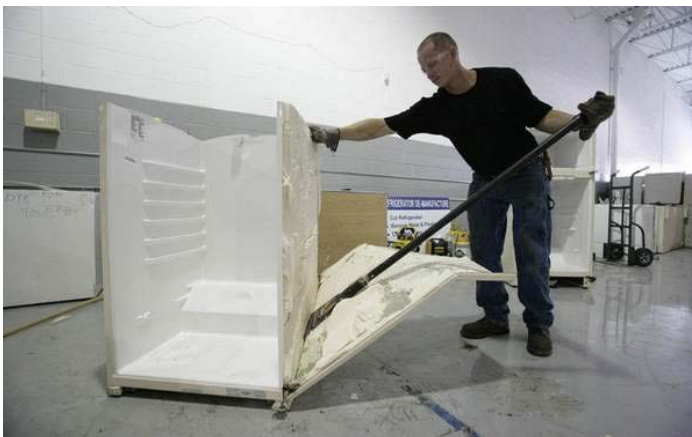
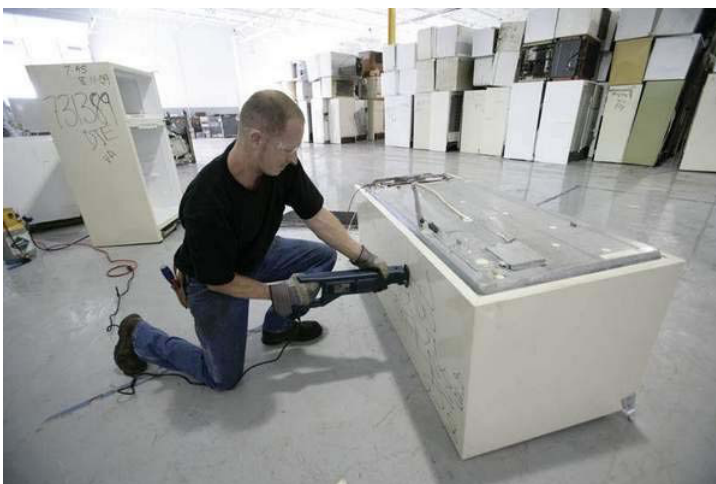
7 Appendix 1: Photo documentation of the manual dismantling of fridges at a recycling company in the USA

The following photographs document the manual disassembly of refrigeration appliances in the USA (www.freep.com).
