Risks of Nuclear Ageing

Technical characteristics of ageing processes and their possible impacts on nuclear safety in Spain

S. Mohr, S. Kurth
Greenpeace, Valencia,
November 2014

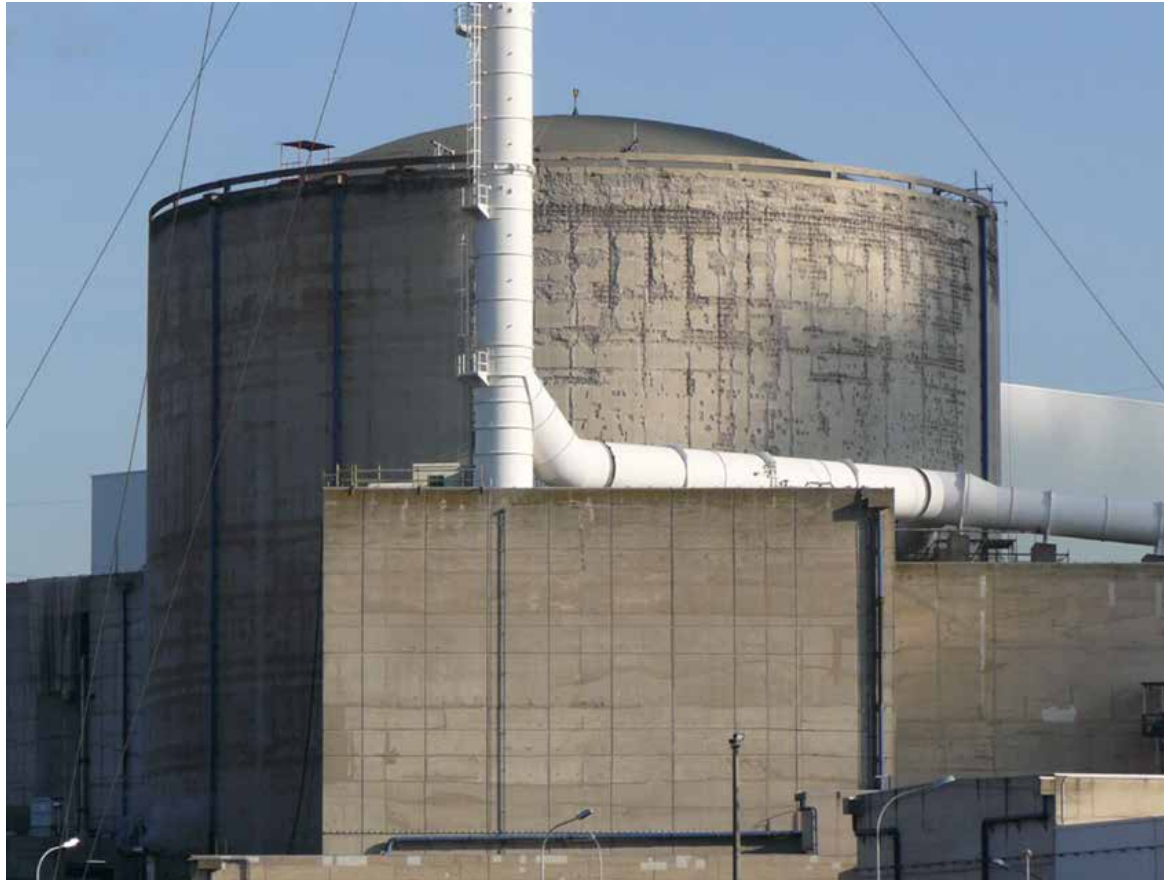
Case study: Containment Ageing

In 2009 the Belgian nuclear operator GDF-Suez/Electrabel realized that the containment building of the Tihange 2 reactor had been damaged.

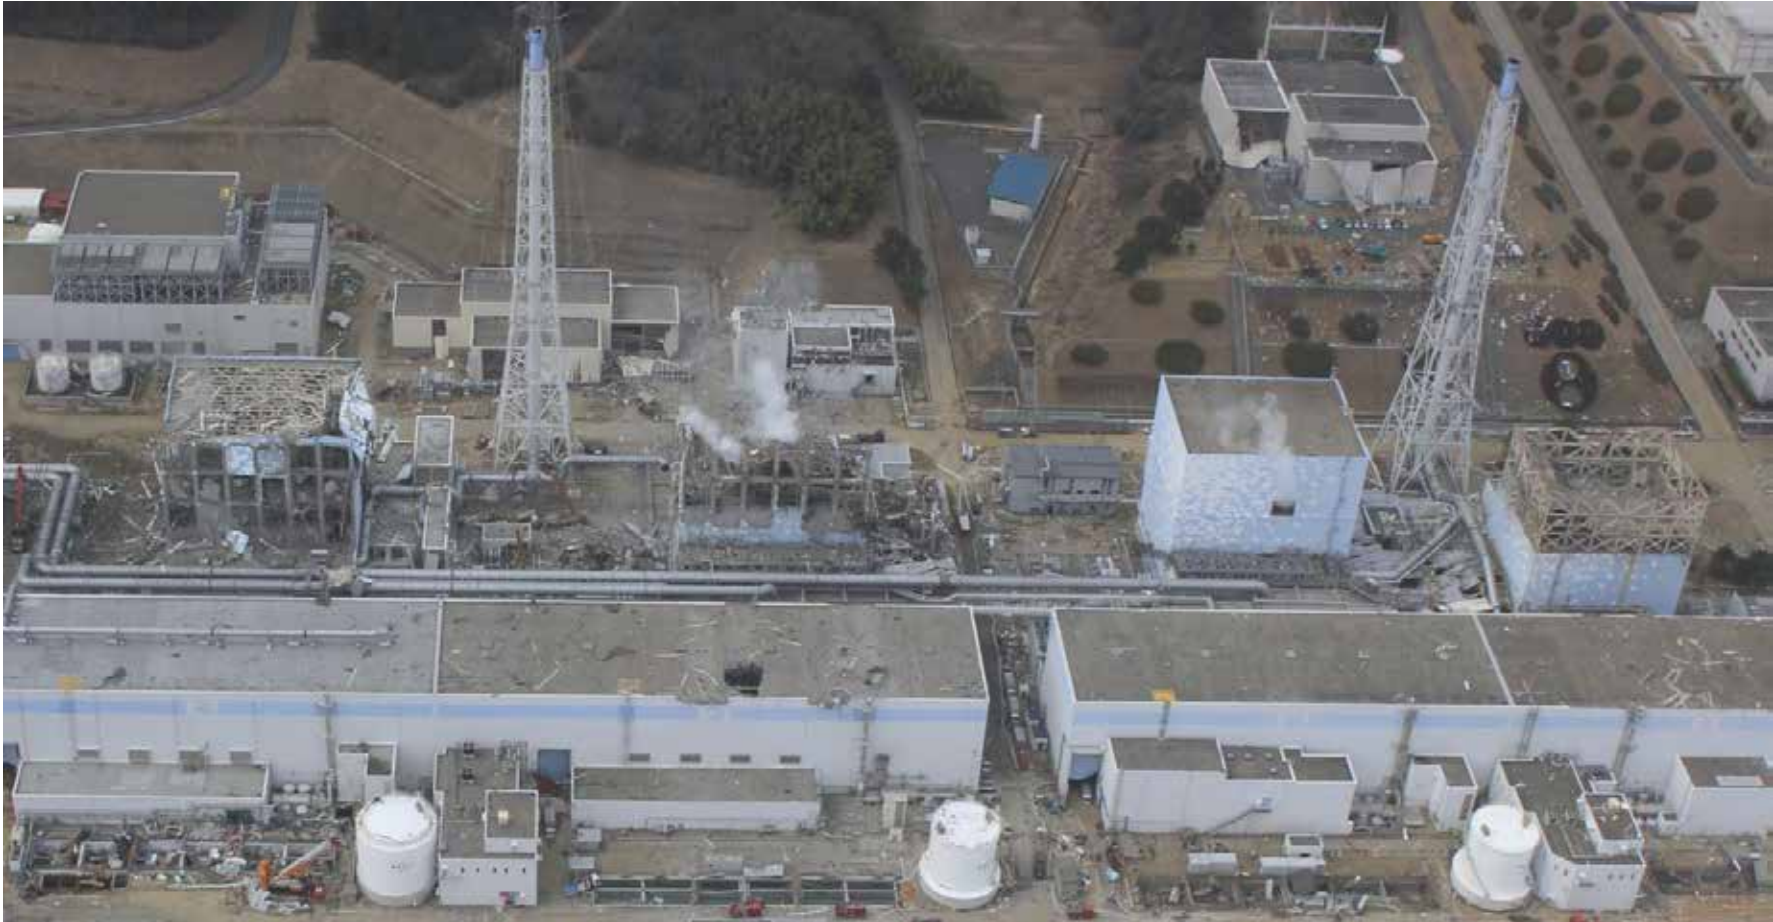
Basic design of protection against earthquake and flooding

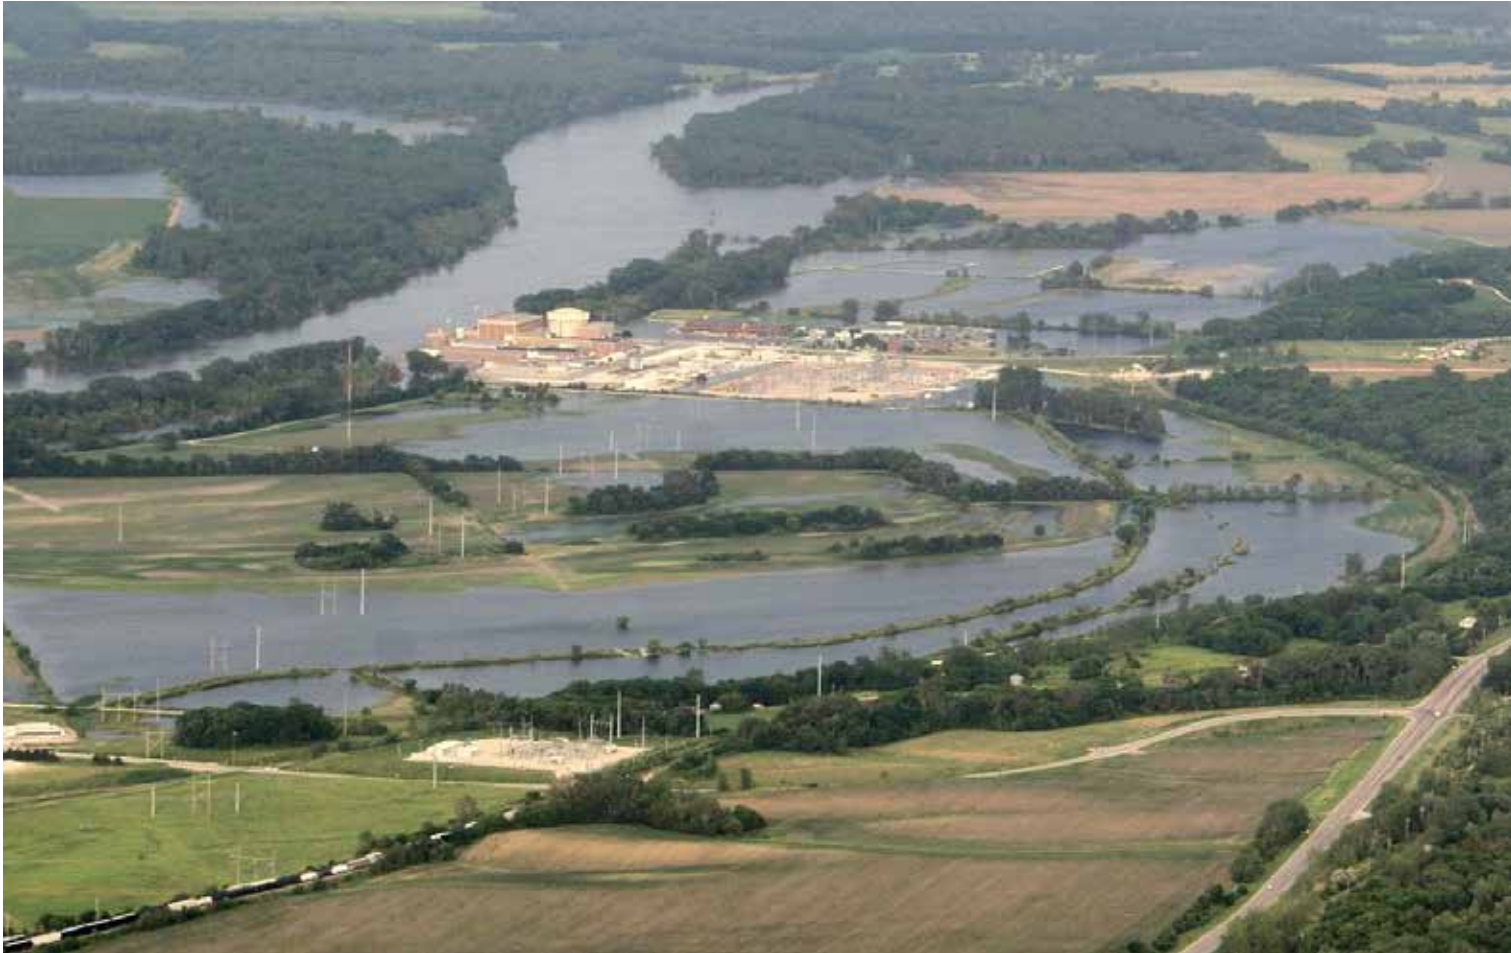
Flooding at Fort Calhoun nuclear power plant, United States, 2011.

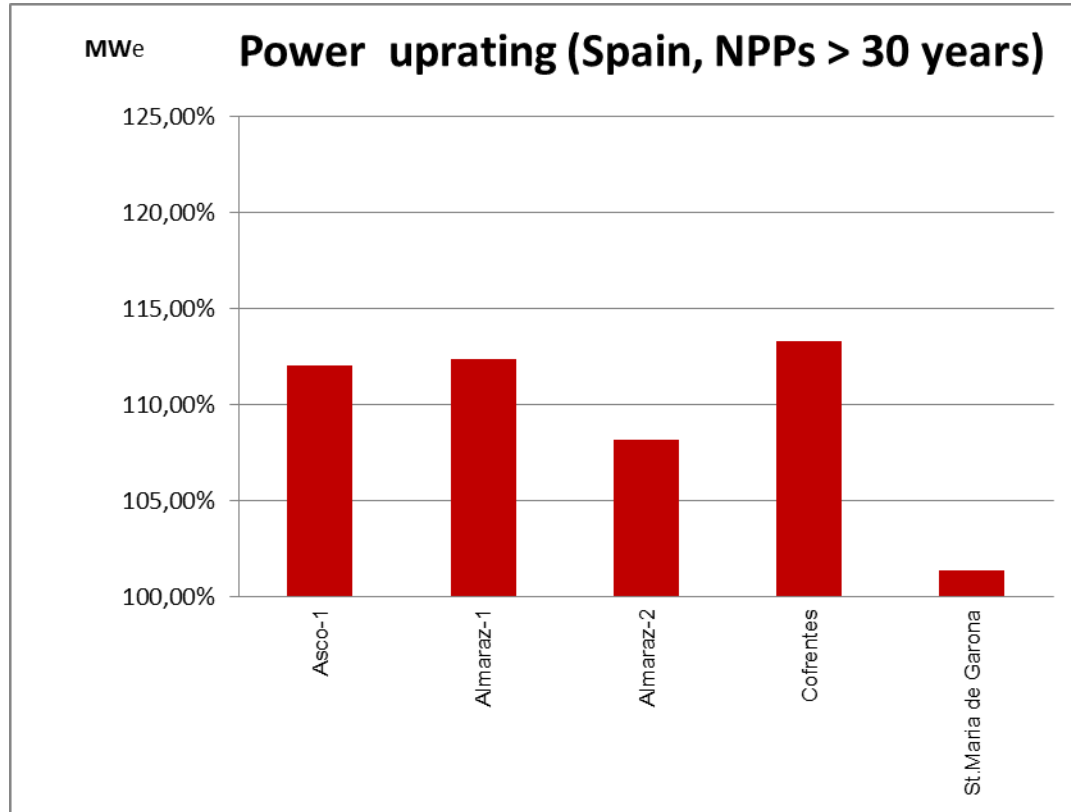
Power Uprating

Status of
November 2014

- The process of increasing the maximum power level at which a commercial reactor may operate is called a plant power uprate (PPU). To increase the power output, the reactor will be refueled with either slightly more enriched uranium fuel or a higher percentage of new fuel.
